C5-M Anti-Corrosion Battery Storage for Telecom Sites: Solving Real-World BESS Challenges

The Unseen Enemy: Why Corrosion is Crippling Your Telecom Site's Battery Backup (And What We Can Do About It)

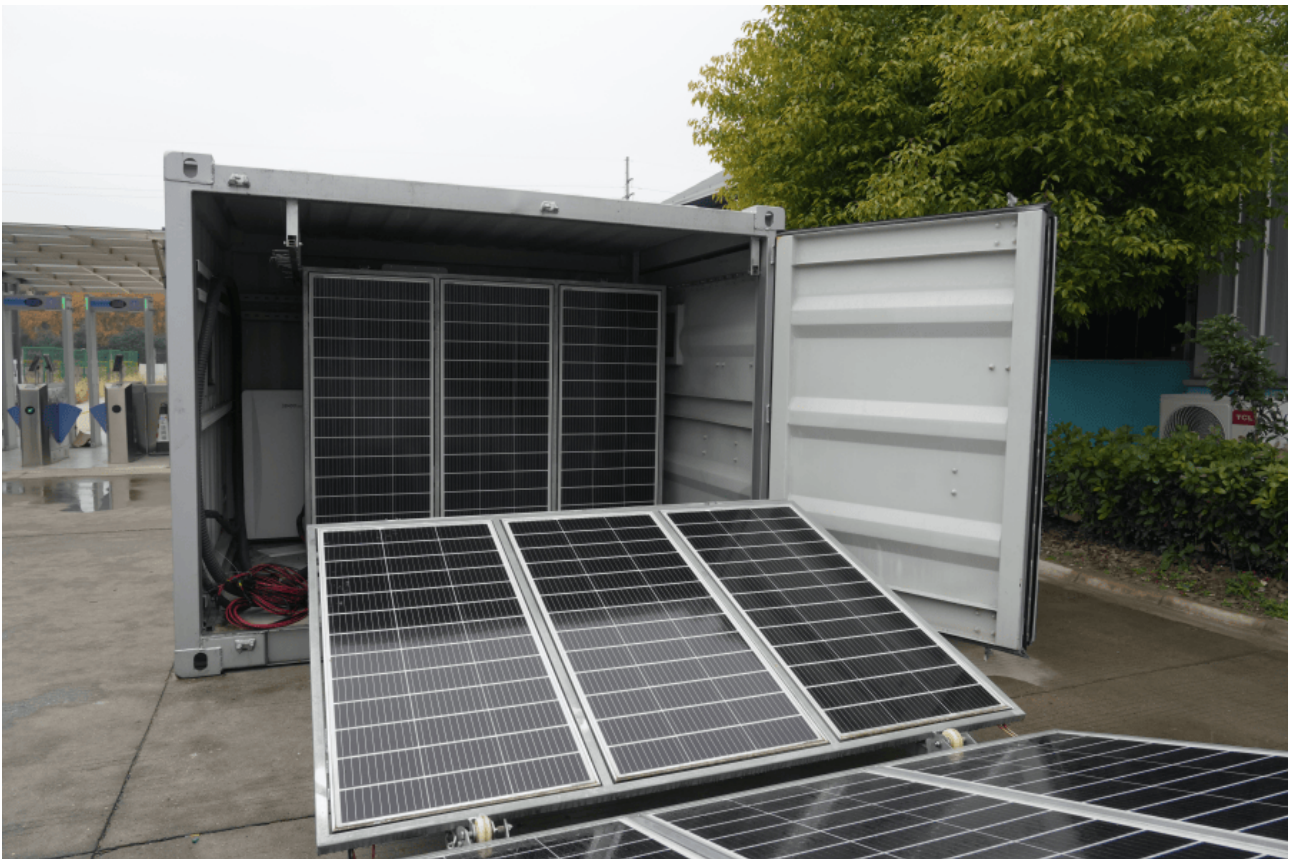
At Highjoule, when we develop a containerized BESS for challenging telecom sites, C5-M isn't a coating we add later. It's a design philosophy. It means hot-dip galvanized structural steel, multi-layer epoxy/polyurethane paint systems with a dry film thickness measured in mils, not microns. It means stainless steel fasteners, double-sealed cable glands, and climate control systems with corrosion-resistant coils and filters. Honestly, it's the difference between hoping it lasts and knowing it will.
